**DEPARTMENT OF TRANSPORTATION****DIVISION OF ENGINEERING SERVICES**

Contract #: 04-0120F4Cty: SF/ALA Rte: 80 PM: 13.2/13.9File #: 69.28**WELDING INSPECTION REPORT****Resident Engineer:**Siegenthaler, Peter**Address:** 333 Burma Road**City:** Oakland, CA 94607**Report No:** WIR-018358**Date Inspected:** 16-Nov-2010**Project Name:** SAS Superstructure**OSM Arrival Time:** 700**Prime Contractor:** American Bridge/Fluor Enterprises, a JV**OSM Departure Time:** 1900**Contractor:** Zhenhua Port Machinery Company, Ltd (ZPMC), Changxing Island **Location:** Shanghai, China**CWI Name:** Mr.Qiu Wen.**CWI Present:** Yes No**Inspected CWI report:** Yes No N/A**Rod Oven in Use:** Yes No N/A**Electrode to specification:** Yes No N/A**Weld Procedures Followed:** Yes No N/A**Qualified Welders:** Yes No N/A**Verified Joint Fit-up:** Yes No N/A**Approved Drawings:** Yes No N/A**Approved WPS:** Yes No N/A**Delayed / Cancelled:** Yes No N/A**Bridge No:** 34-0006**Component:** Tower and Orthotropic Box Girder (OBG)**Summary of Items Observed:**

## WELDING INSPECTION REPORT

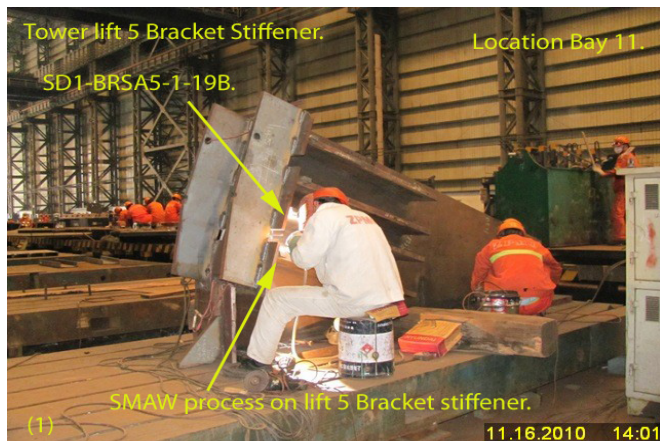
This QA Inspector observed ZPMC qualified welding personnel identified as 054460, Perform Shielded Metal Arc Welding (SMAW) on Tower Bracket Stiffener lift 5. Joint identified as SD1-BRSA5-1-19B. ZPMC QC Identified as Xu Jie. The welding parameters as measured using QC's calibrated instrument appeared to be in general compliance with WPS-B-T-3213-Tc-U4b. For more information see below attached picture number 1.
